# Manhole Inspection Summary

Manhole # S02GG2012MH

Insp Date: **7/18/06 9:14 AM**

**Location** Address: **6712 WESTBROOK RD**

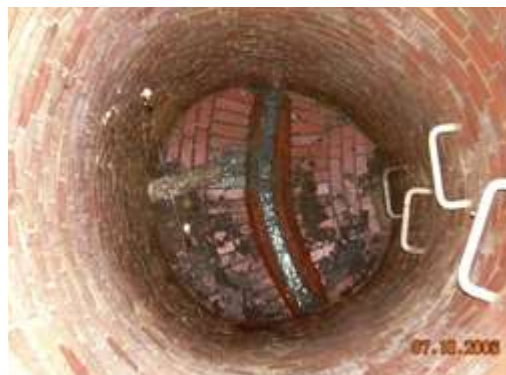
Top View

Corbel and Barrel infiltration. Evidence of surcharge - Bench debris.

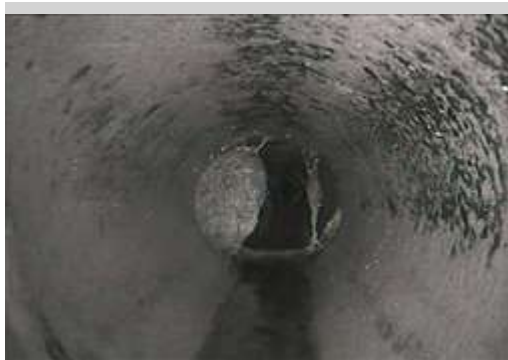
Inside the I5

Root intrusion.

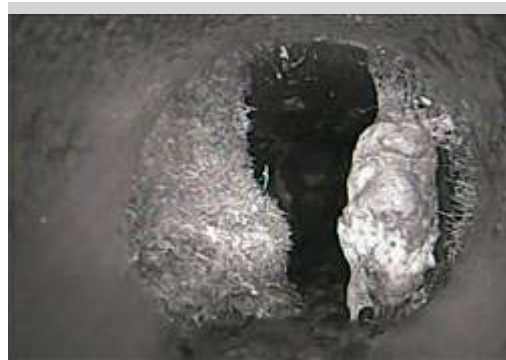
Inside the O12

Root intrusion.

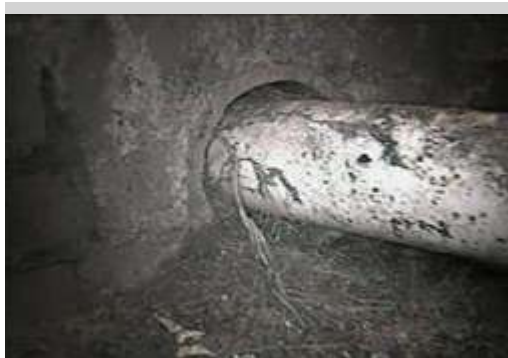
Defect

Barrel infiltration. Root intrusion around the I9.

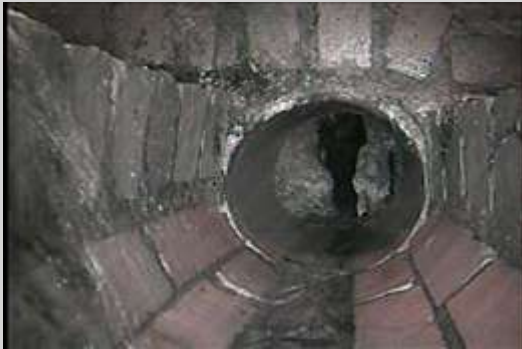
### 8 in. Circular Gravity Sewer Pipe Out @ 12 O'Clock

Infiltration: **Evidence** Pipe Seal Cond: **Unknown**
